CASE STUDY

AQUIS addresses corroding air handling units for Boston College

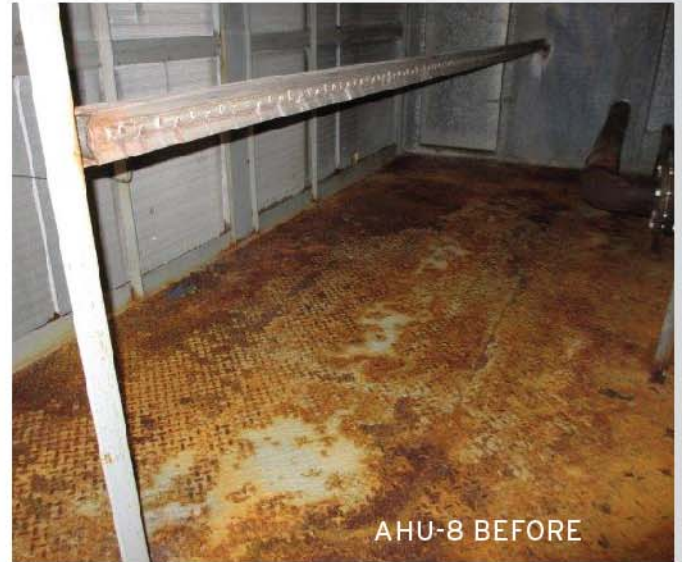
AHU-8 BEFORE

Higgins Hall is a science and research building on the main campus at Boston College, home to over 20,000 students in Chestnut Hill, Massachusetts. Their built-up air handling units, manufactured by Haakon Industries, had significant corrosion on the chamber floors and walls, resulting in holes that could potentially cause damaging water leaks in the building. Boston College selected AQUIS to refurbish the interior of six large units because they wanted to extend the life of the air handlers with a fully compliant and cost effective system.

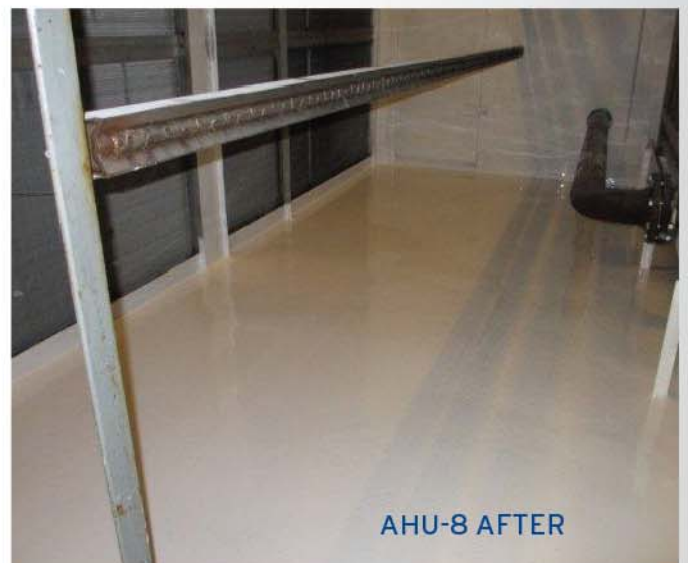
AHU-8 AFTER

AQUIS installed its engineered coating systems on the chamber floors, walls, ceilings, and fan housings.

- Chamber floors were completely sealed to eliminate potential water leaks and restore structure.
- Installation was completed with minimal down time, zero VOCs, and did not require the removal of existing equipment.
- The building’s AHUs are now fully compliant with NFPA 90A and the fire code (ASTM E84 25/50).
- The system now has the benefit of an antimicrobial surface to eliminate bacterial/fungal growth.
