# Clear Solutions

## Bergen Regional Medical Center

### AN AQUIS® CPR-1 SYSTEM CASE STUDY

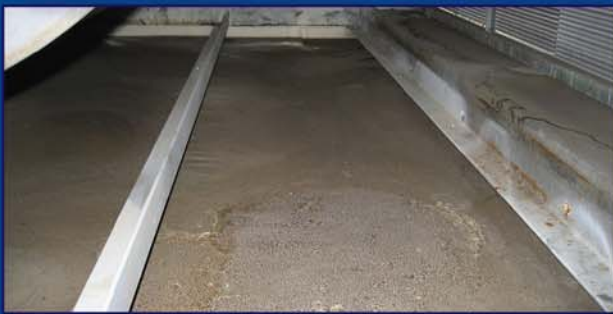
### NON-COMPLIANT CONDITION

Air Quality Innovative Solutions (AQIS) was asked by Bergen Regional Medical Center (BRMC) to conduct an assessment of their HVAC air handlers. What AQIS found was typical of many aging air handlers; the condensate pans and fan chamber floors had been installed without adequate surface pitch for drainage of condensate water. Consequently, the air handlers drained poorly and were prone to standing water and biological growth which required the constant attention of the facilities management team. As a result of years of standing water, the condensate pans and fan chamber floors were severely rusted. This condition had led to damaging water leaks, reduced air handler efficiency, and compromised structure of floors and walls. The "before" condition of the BRMC air handlers can be seen in the following photograph.

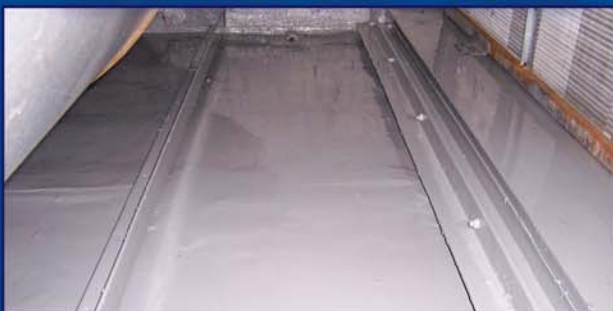
### COMPLIANT CPR-1 SYSTEM

The CPR-1 System was installed in all air handlers at a pitch in excess of 1/8" per linear foot to the drain (per ASHRAE 62) to ensure the prompt removal of condensate water and the complete elimination of standing water. A schematic of the CPR-1 System can be seen in the illustration at right. The removal of standing water coupled with a built-in active antimicrobial, has virtually eliminated biological growth on the floors of the BRMC air handlers. This improvement in performance has enabled BRMC to successfully meet their JCAHO (Joint Commission on Accreditation for Healthcare Organizations) Utilities Management Plan.

After a comprehensive evaluation of the BRMC air handlers, the AQIS Assessment Team determined that they were prime candidates for remediation with the AQUIS® CPR-1 System. The CPR-1 System is a patent pending and proprietary multi-layer system for the remediation of problematic condensate pans in commercial and industrial HVAC systems. The CPR-1 System is the only system of its kind that is fully compliant with all applicable regulations for use in HVAC systems as defined by the NFPA, ASHRAE, the EPA and others.
